Under certain circumstances, a vacuum interrupter may fail after placed back in service due to salt water exposure.

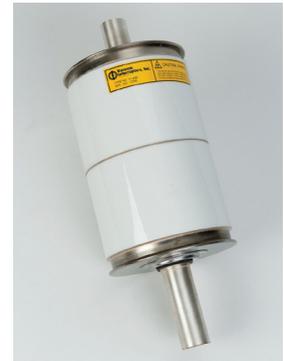
External view of typical vacuum interrupter.

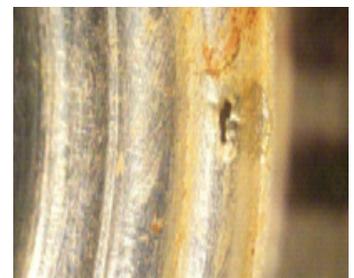
Corrosion in stainless steel bellows comes in two main forms: galvanic and chloride corrosion. Galvanic corrosion occurs as a result of two dissimilar metals being in contact with each other in a conducting, corrosive environment [2]. For example, the stainless steel bellows and copper-based brazing material in a vacuum interrupter will experience galvanic corrosion after being exposed to saltwater, Figure 2. Galvanic corrosion is observed as pitting in the materials. The driving force of galvanic corrosion is the differential voltage between the two materials.

Figure 1. Galvanic corrosion in stainless steel bellows.

One of the best 300-series stainless steels is type 316. Even this alloy will, if unprotected, start corroding under soft washers, in o-ring grooves, or any other tight crevice area in as little as one day, and it is not unusual to have penetration of a tenth of an inch in a crevice area after only 30 days in seawater. If water flows fast past a stainless steel, more oxygen is delivered to the stainless steel and it corrodes less. For this reason, stainless steels have been successfully used for impeller blades and propellers. These need to be protected from corrosion when there is no flow, Figure 1.

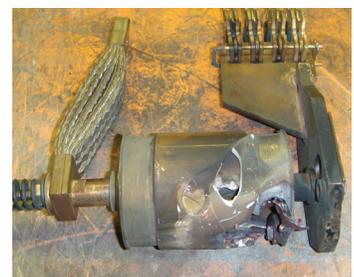
Failure of the bellows in a vacuum interrupter will result in loss of vacuum. Without a proper vacuum, a vacuum interrupter will not be able to properly insulate the applied voltage possibly resulting in catastrophic failure. If vacuum circuit breakers have been exposed to salt water, whether partially or fully, the mechanism should be properly reconditioned, or preferably replaced.

Figure 2. VI exposed to salt water then placed back into service failed catastrophically 180 days later.
